**Accident Investigation Report**  
**Underground Coal Mine**

**Fatal Rib Fall Accident**

**Paramont Coal Company Virginia, LLC**

**Deep Mine 41**

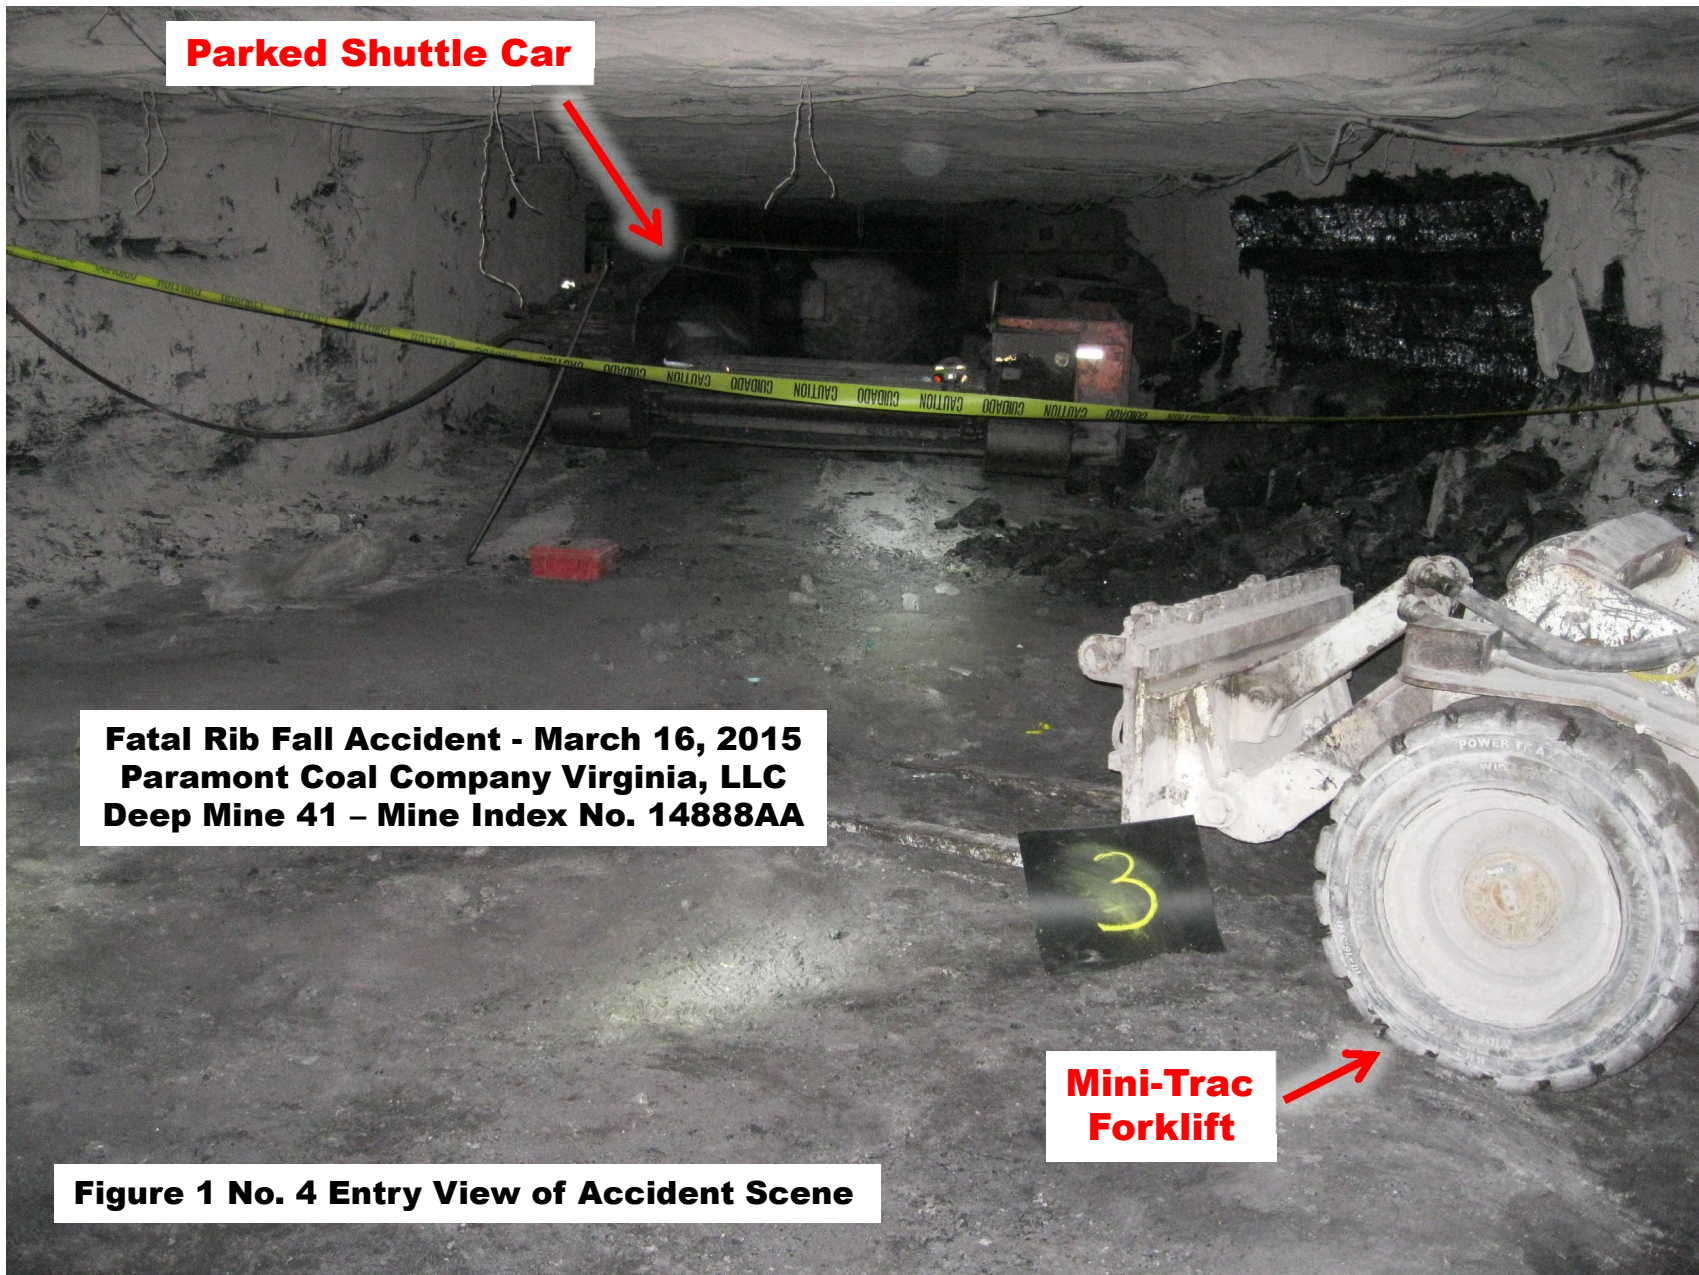
**Figure 1 No. 4 Entry View of Accident Scene**

**Parked Shuttle Car**

**Mini-Trac  
Forklift**

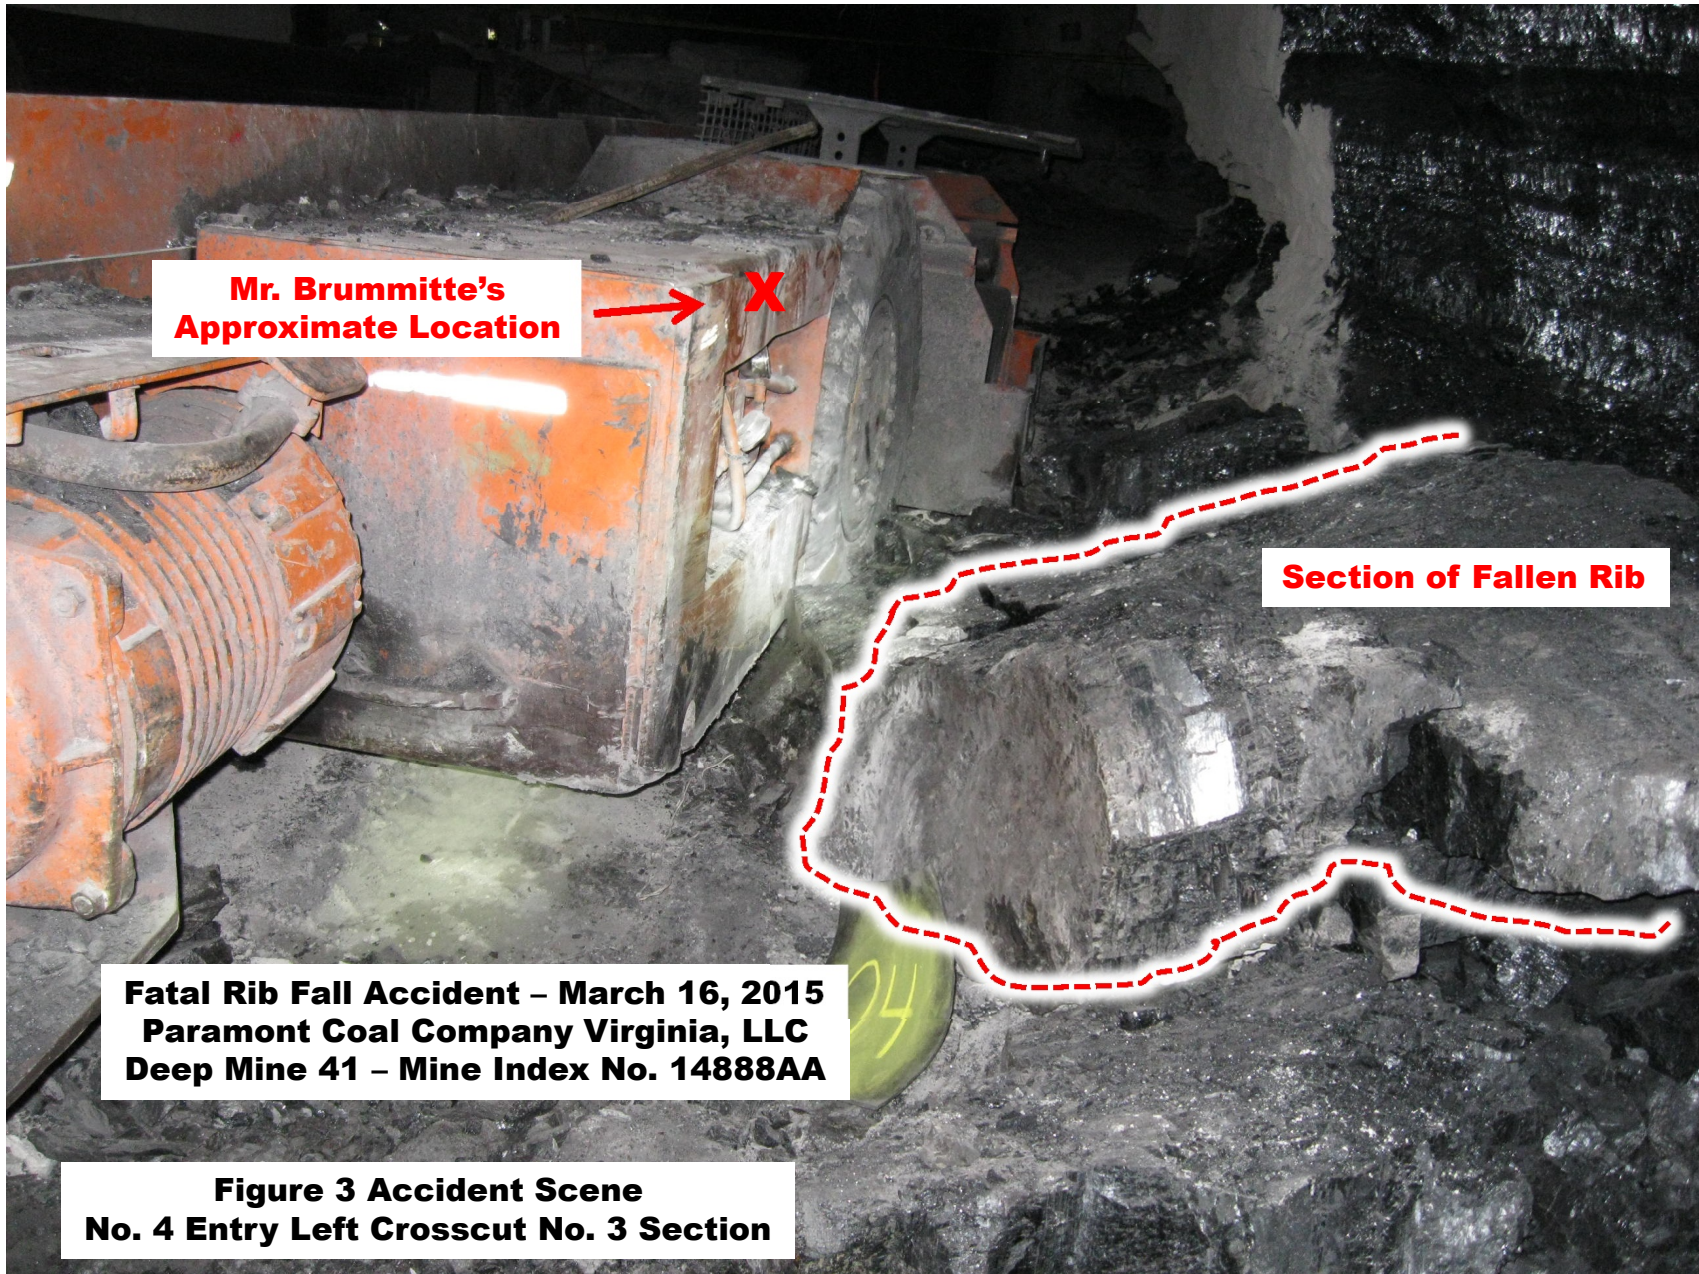
**Figure 3 Accident Scene  
No. 4 Entry Left Crosscut No. 3 Section**

3. The rib material broke after it separated and fell from the coal pillar into the crosscut. The section of fallen rib that struck Mr. Brummitte measured approximately 90 inches long, 45 inches high, and varied from 15 to 18 inches thick. The fallen rib broke into two sections. The estimated weight of the section of fallen rib that entrapped Mr. Brummitte was approximately 1.4 tons. Smaller sections of broken rib material surrounded the larger section of rib roll on the mine floor and small sections of fallen rib were located on the mine floor along the right inby rib of the crosscut. The cavity along the inby rib of the crosscut measured approximately 19 feet in length.

9. Mr. Brummitte's position was estimated to be approximately 56 inches from the right inby rib of the No. 4 entry left crosscut when the rib material fell. Mr. Brummitte was found entrapped between the shuttle car frame and a large section of fallen rib, which was positioned against his right side chest area. Mr. Brummitte was trapped in a crouched semi upright position and was kneeled down on one knee facing the direction of the No. 3 entry with his left shoulder against the pump motor compartment of the shuttle car.

**Mr. Brummitte's  
Approximate Location**

**Section of Fallen Rib**

1. All miners will receive retraining concerning potential hazards associated with loose coal ribs and work place examinations.
2. Employees should make frequent and thorough roof and rib examinations.
3. Adequately support or scale down any loose roof or rib material from a safe location, use a bar of suitable length and design when taking down loose roof or ribs.
4. Employees should be aware of their surroundings at all times and be alert to potential hazards when working or traveling near ribs.
5. Areas of close clearance between the ribs and equipment should be avoided.
6. Rib bolts should be installed on cycle using consistent installation patterns for the best protection against rib falls.
7. Employees should always remain alert to changing conditions and report any abnormal roof or rib conditions to mine management.

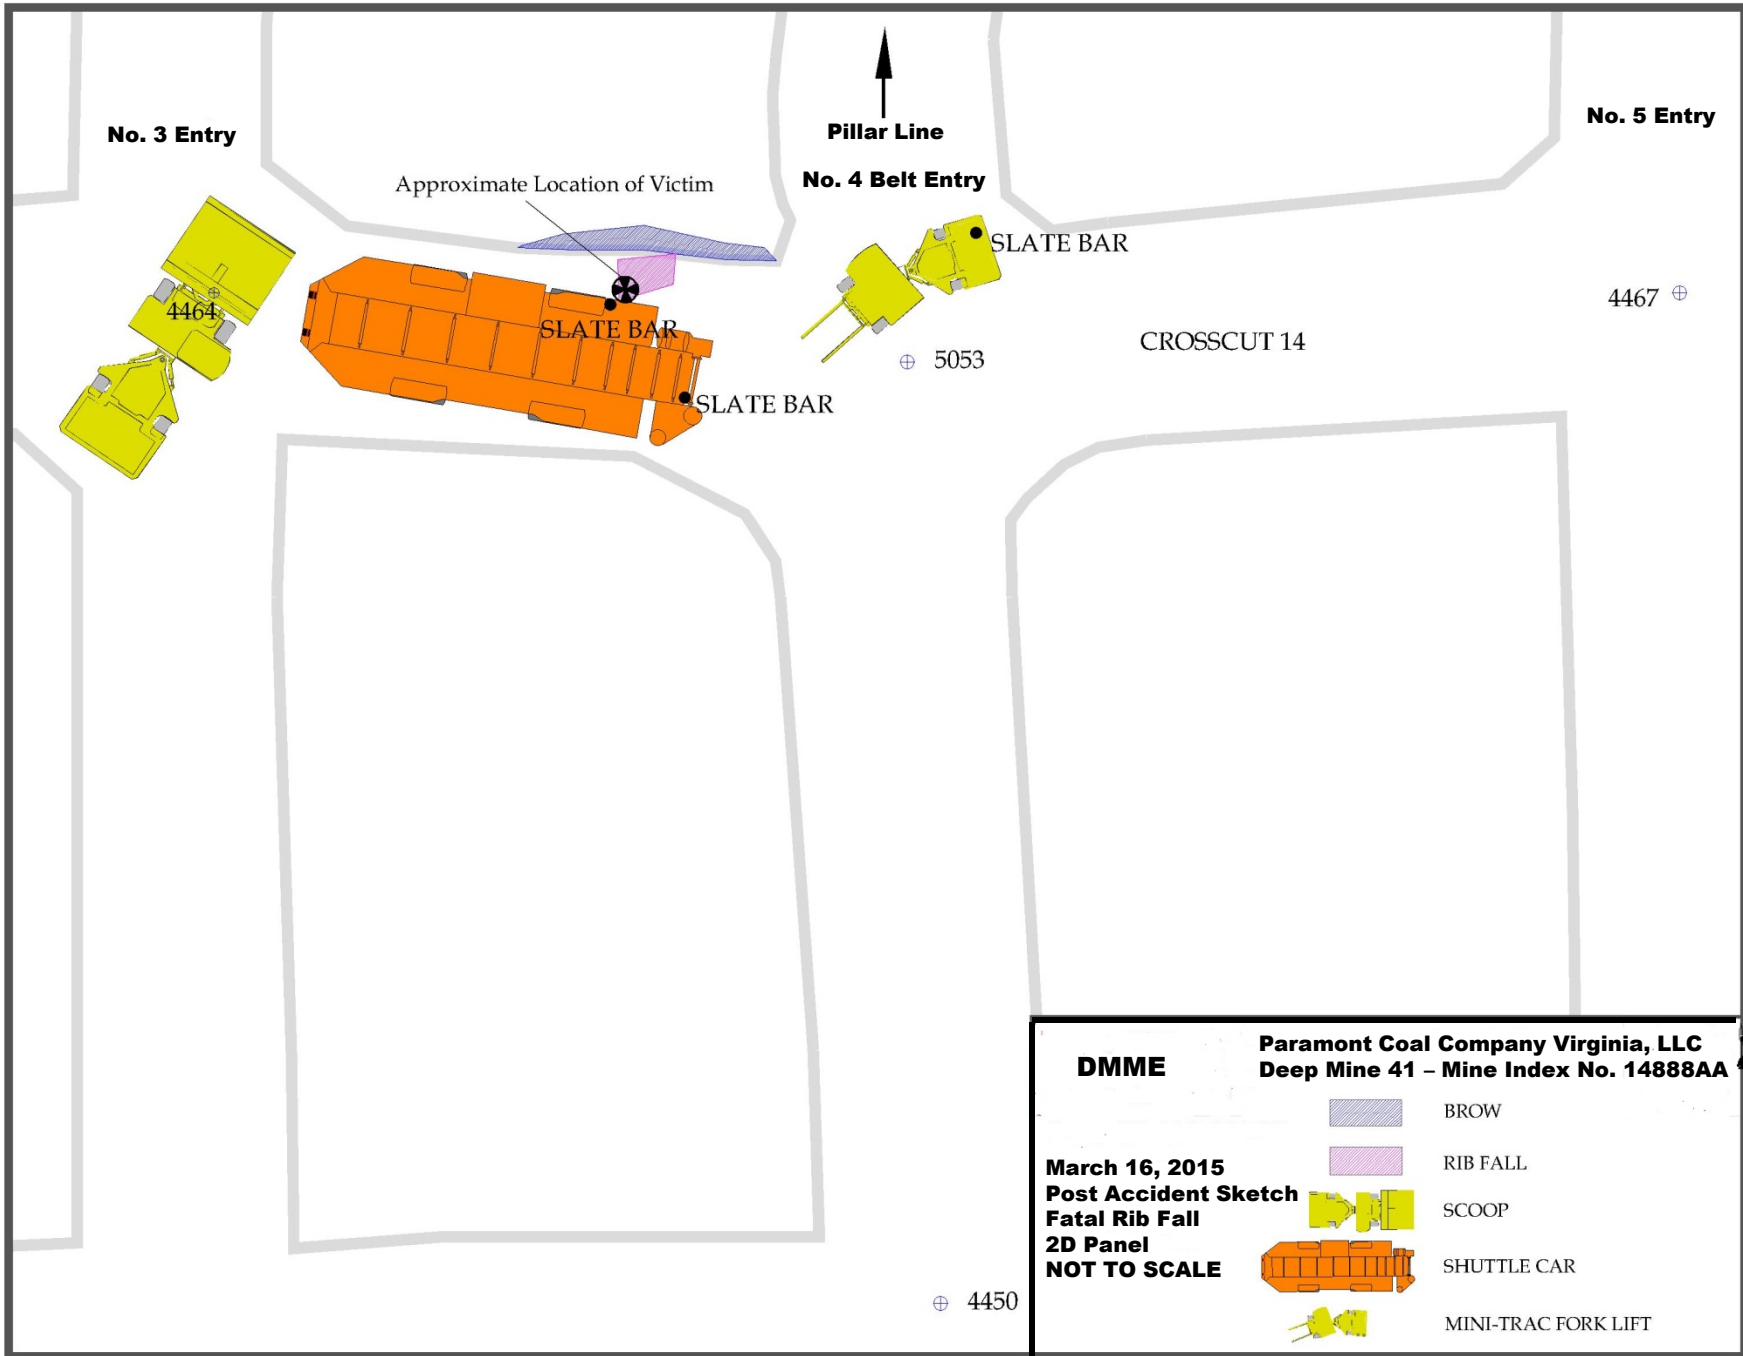
**March 16, 2015**  
**Post Accident Sketch**  
**Fatal Rib Fall**  
**2D Panel**  
**NOT TO SCALE**

RIB FALL

SHUTTLE CAR

MINI-TRAC FORK LIFT
