**Accident Investigation Report**  
**Underground Coal Mine**

**Fatal Rib Fall Accident**

**Paramont Coal Company Virginia, LLC**

**Deep Mine 41**

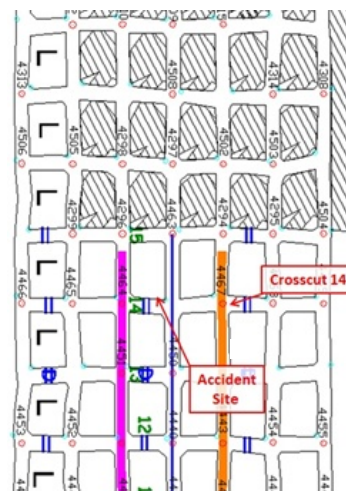
There was no over mining or under mining at this mine. The overburden at the accident scene was approximately 700 feet. An analysis of pillar stability for the No. 3 retreat mining section was conducted using the Analysis of Retreat Mining Pillar Stability (ARMPS) program provided by the National Institute for Occupational Safety and Health (NIOSH). The values exceeded the NIOSH recommended pillar stability factors of

safety. In addition to the five pillars extracted during retreat mining, a 32 foot deep barrier cut was also mined from the 130 foot coal barrier remaining between the 2D panel and 2C panel. The overall pillar stability did not appear to be a contributing factor with respect to the rib roll accident.

Coal pillar rib failure can occur as the edges of the pillar yield under the excessive pressure of overburden rock weight, abutment pressures, as well as fractures / cracks or other natural defects that can cause sections of rib to become unstable, detached, and fall away from the pillar. The rib roll material located at the accident scene consisted of coal with partings of shale rock and slicken side rock embedded in the seam. Noticeable slicken side rock was also present at the roof line at the topmost part of the coal seam. The slicken sides probably contributed to the instability of the section of fallen rib.

The type of rib roll that occurred is generally referred to as a vertical slab or plate-like rib failure. Loose / fractured ribs were observed at a number of locations on the No. 3 section for a distance of five crosscuts outby the pillar line. Most of the fractured rib conditions would have been located outby the section loading point prior to the belt being moved back one crosscut by the owl shift move crew when the accident occurred. The rib conditions did not appear to have resulted from abutment pressures from pillar extraction but most likely occurred as a result of the structural features of the coal seam.
